Technical Note N-1037

CORROSION OF DSRV MATERIALS IN SEA WATER -
SIX MONTHS EXPOSURE

Fred M. Reinhart

NAVAL CIVIL ENGINEERING LABORATORY
Port Hueneme, California 93041

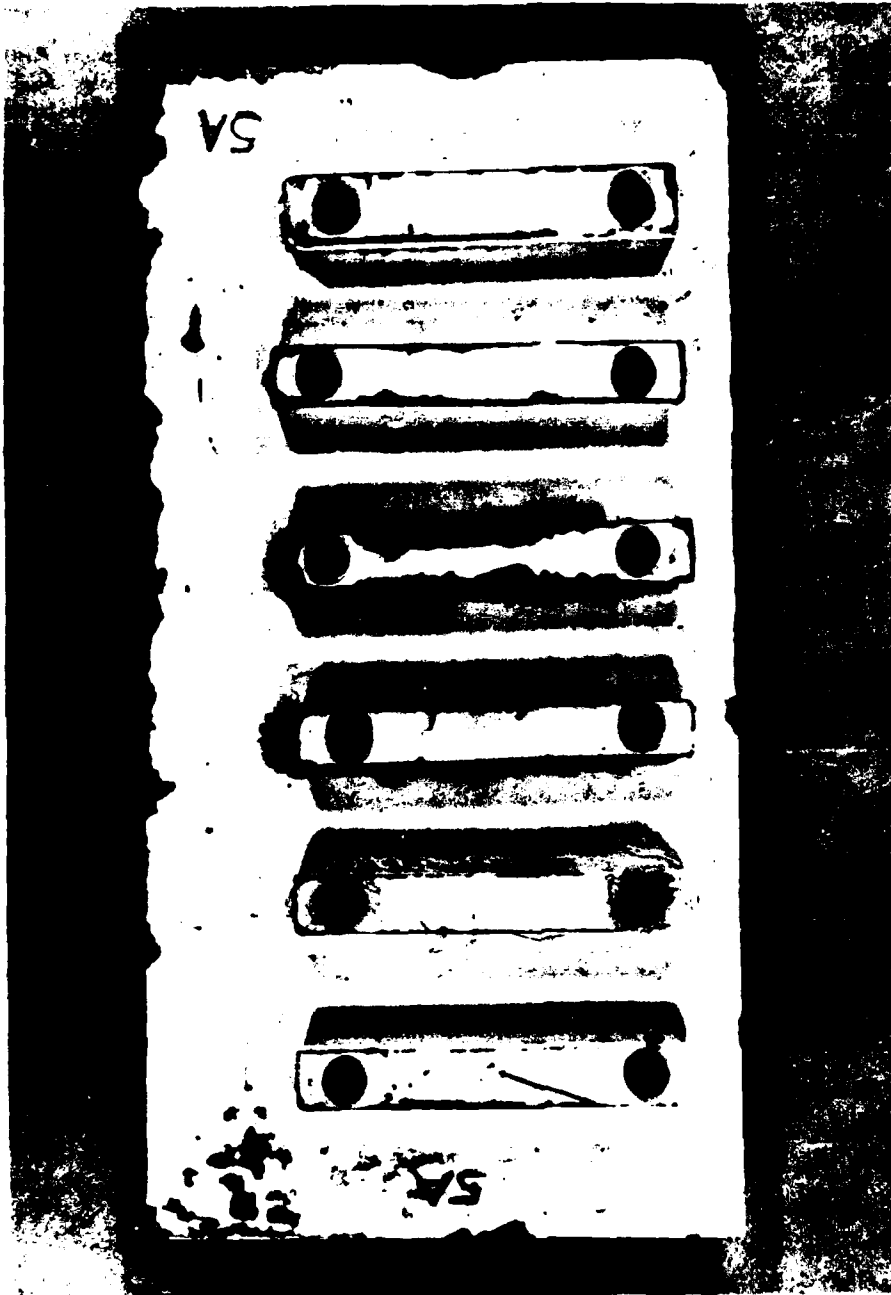
Specimens simulating four conditions noted in the above paragraph were exposed at mean tide level at the Point Mugu site for evaluation. Typical specimens are shown in Figures 1 and 2. The specimen in Figure 1 is an anodized and painted 6061-T6 aluminum alloy panel to which is fastened six painted 6Al-4V titanium alloy strips with A-286 stainless steel fasteners.

Figure 1. Painted titanium alloy strips bolted to an aluminum alloy panel with stainless steel bolts.
